Minutes of Credition Town Council's Parish Paths Committee Meeting, held on Tuesday, 13th October 2015, at 5.30 pm, at the Council Chamber, Market Street, Credition

Path	Location	Update	Picture	Resolved actions from Parish Paths Committee Meeting, held on Tuesday, 13 th October 2015 – Minute no. 10
2		Throughout the winter it will be ankle deep in mud.	Taken 18/9/15

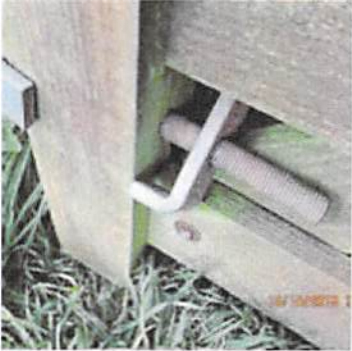
Monitor over the Winter. In the meantime, obtain quotations to remove the top layer of soil and lay scalplings.
2	at Dog Leg	Nut is missing from bracket holding lower frame of gate. Also a nut is loose on fixing latch. Looks to be very recent because of shiny area where bolt used to be! Gate functions OK at the moment.

Mr Chudley to purchase the necessary fixings and install, with the cost of goods being met by the Council.

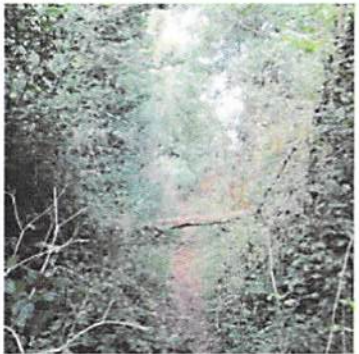
15	Hunnivar's Lane near housing estate	<p>Hedges all in good order.</p> <p>Actual path needs weed killer on both outer edges for most of its length, and weed killer between paving slabs over just a small area before the roots of the grass are strong enough to lift the slabs.</p> <p>Generally cosmetic rather than causing difficulty to users.</p>		<p>Urban & Rural Tree Services Ltd provided quote.</p> <p>Weedkiller is not permitted. Work cannot be funded by the P3 Parish Paths budget.</p>
18		There is a log blocking the entire path, 12" diameter, two feet above the ground.

Path Warden to organise removal.
19	Going East	Looks like new surface finished today, all hedges clear.		No action required.

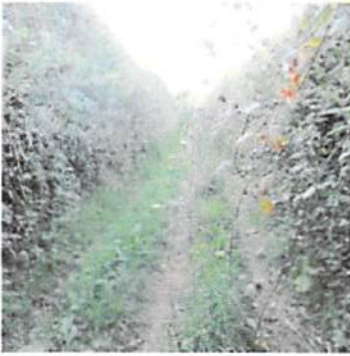
19	North/ south	Just stray briars here and there not a problem, but one short area north of Lower Parks Farm needs attention to path and hedges.

<p data-bbox="1086 486 1433 517">North of Lower Parks Farm</p>	<p data-bbox="1455 114 2057 145">Urban & Rural Tree Services Ltd provided quote.</p> <p data-bbox="1455 189 2063 294">This area may have been picked up by the second cut in September, if not the cutting area will be extended to cover this section.</p>
19	19/28 junction	Gate is difficult to manoeuvre because the lower bracket is not holding the frame of the gate securely, thereby allowing the gate to drop.

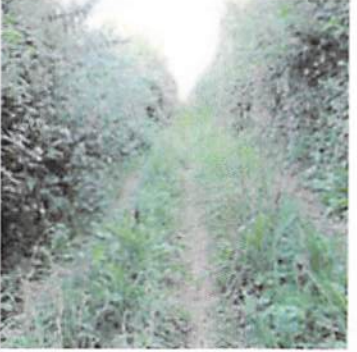
<p data-bbox="1455 564 1858 595">Path Warden to organise repair.</p>
19	Going north, part of stretch between Lower Park Farm and Town	<p data-bbox="429 980 1057 1246">Photograph is typical - problem for walkers is that the path is 7/8 feet wide, with three tracks on which to walk. It is divided because of two permanent lines of weeds. The centre track is barely wide enough to walk on, the two outer ones mean brushing head and shoulders with the hedges, and in both cases, walkers get wet legs up to the knees because of the height of the weeds.</p> <p data-bbox="429 1285 1057 1411">This does not deter hardened walkers. But if you have received a complaint, or it is just cosmetic, it appears the only thing to do is to top the lines of weeds as low as possible.</p>	<p data-bbox="1101 980 1420 1042">Footpath 19 northbound above Lower Park Farm</p>

<p data-bbox="1455 980 2057 1011">Urban & Rural Tree Services Ltd provided quote.</p> <p data-bbox="1455 1050 2023 1081">As above. Will be covered by cutting program.</p>

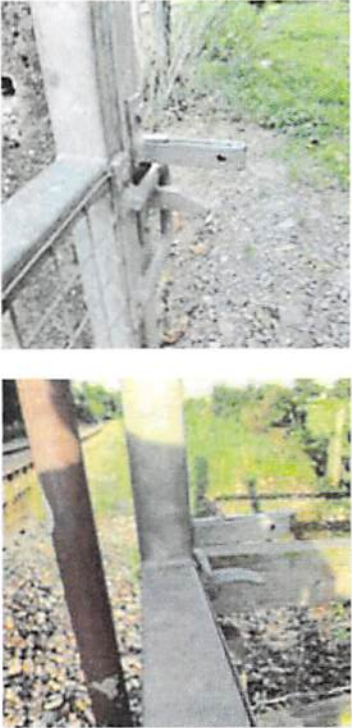
19		Catches are missing on both gates used to cross the railway.

Gate is self-close so no issue. Landowner's responsibility.
22	Downshead Lane	Downshead Lane 01/10/15 - 100 yards east of junction with footpath 23.

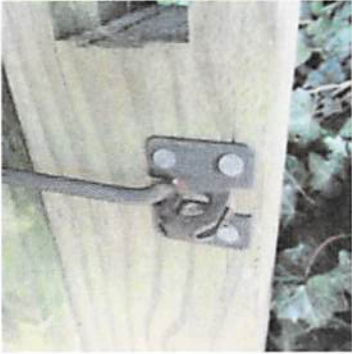
22		<p>The hook has broken off the gate on field boundary 50 yards before mobile phone aerial.</p>

<p>Path Warden to organise repair.</p>
24		<p>Briars need cutting back</p> <p>(Change of boundary and footpath numbering between the date of the old map and the new map which arrived recently. This affects only the bridge at River Creedy and the leat just Crediton side of river.)</p>	<p>Footpath 24 Briars</p>

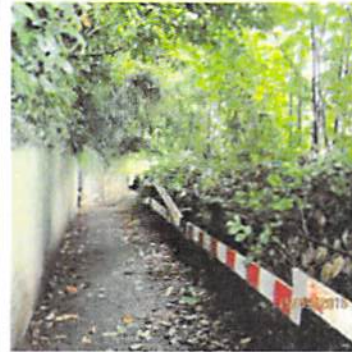
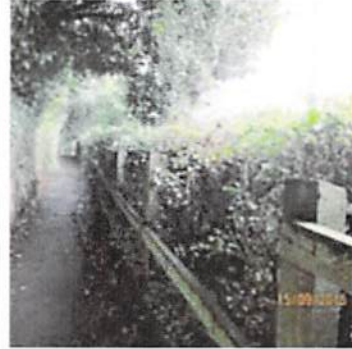
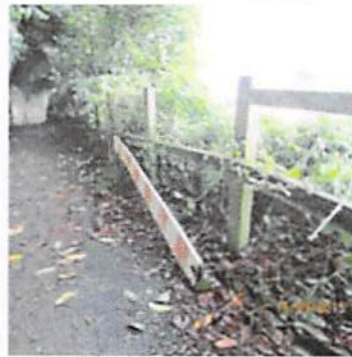
Penton
Lynch

Top safety rails missing half dozen places, also lower ones missing here and there. Temporary ones elsewhere (red/white plastic) out of place, I have picked one off ground.

Urban footpath maintained by Neighbourhood Highway Officer, Stephen Tucker.

Office to contact Stephen Tucker.

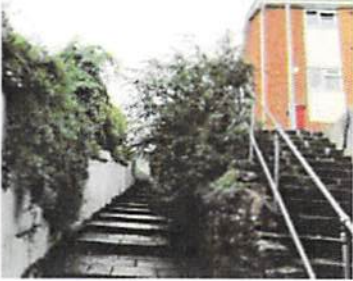
26		Just couple of shrubs (lilac etc) overhanging steps not terribly inconvenient.

Urban & Rural Tree Services Ltd provided quote. DCC currently cut back as much as necessary. No further action is required.
28		Two metal gates (about 50 yards apart) in very good order but evidence of not being used very much because it is simpler to duck under the single strand of barbed wire than to open the gate and walk around it. Needs replacement of few rows of barbed wire each side of each gate, condition of posts unknown.	<p>Track under single wire</p>

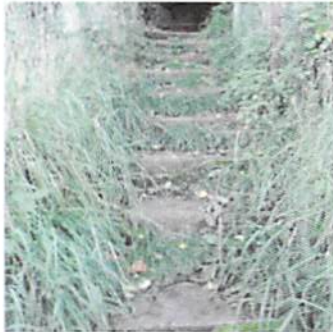
28		Two gates on diverted length of path have been dealt with as you know.		No action required.
29		St Saviours Steps, only the lowest third is in need of attention.	<p>Lower part of 29 as it is today</p>

<p>Urban & Rural Tree Services Ltd provided quote.</p> <p>Already under cutting program. Picked up by second cut.</p>

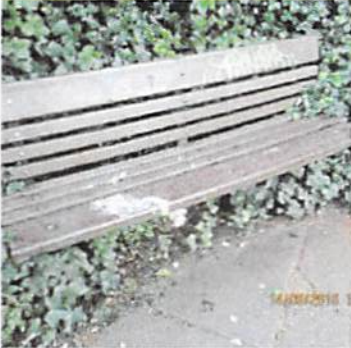
33		<p>125 steps - I have done this one couple of times a week for 10 years and it is probably the most used footpath in town. Always a lot of litter, but seems to be cleaned up sometimes. The seat situated half-way has awful graffiti type paint on it. Loads of food/drink containers, but no bin by the seat. Just around the lower corner is a popular meeting place for youngsters.</p>

<p>Office to contact David Whyte Cleaning Services.</p>
33		<p>There are weeds covering the risers on one part, which could become a slip hazard underfoot.</p>	<p>From the seat going upwards southerly direction</p>

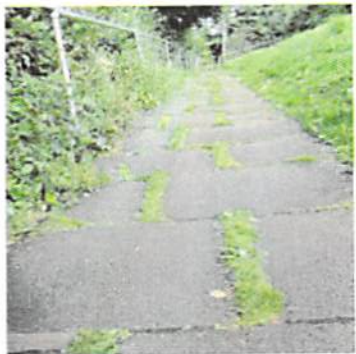
33		<p>There is a short flat paved length, with short grass around almost every slab.</p>	<p>Level section</p>

<p>Urban & Rural Tree Services Ltd provided quote.</p> <p>Urban footpath - Office to contact Stephen Tucker.</p>
33	<p>Update as of 1/10/15</p>	<p>Weed killer has been applied recently at the southern end, exit to Barnfield.</p> <p>I have discovered that the current method used to lessen the hazard of tripping where there are overhanging projections is to create a slope made of mud containing grass and weeds which have been treated with week killer. So therefore, one just has to hope that the weed-free mud will stay perfectly in place long enough for fresh grass and weeds to grow in it to keep it in place.</p> <p>There are two areas with yellow marks, presumably for attention, which are:- the surround of a manhole cover, and an overhanging projection trip hazard.</p> <p>There are probably ten similar trip hazards, plus half-dozen that have been addressed by using the "mud method". Perhaps this is a case for a good overhaul?</p>	<p>Mud repair method</p>

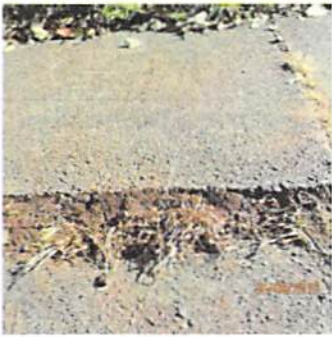
Urban footpath - Office to contact Stephen Tucker.
33		A clearer view of the Mud Method used to repair the path.

Urban footpath - Office to contact Stephen Tucker.
33		"Mud Repair" job on a broken slab.

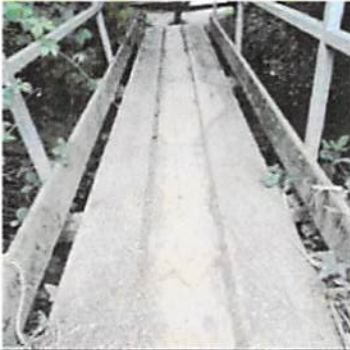
57	Junction 24/57	The bridge over stream before the river has lost most of its non-slip wire mesh covering over the footboards.	<p>Footpath Junction 57 Bridge over Leat/Stream</p>

Path Warden to look at laying new wire.
57		The upper left safety rail on the approach to the bridge is hanging on baler twine – anyone tripping over the lower rail, which is held in place by wire, would have a steep muddy slide into the R.Creedy. This might be Shobrooke P.C but the dodgy bit is our side of the river.	<p>Footpath 57 Bridge over River Creedy</p>

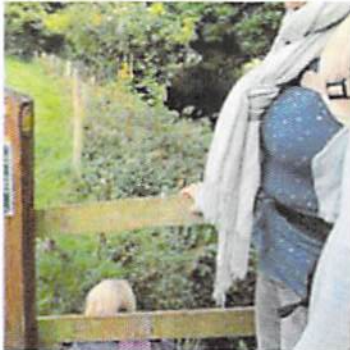
<p>£3,000 budgeted for project. 2016 project that will be looked at next year.</p> <p>Continue to monitor in the meantime.</p>
57		I have today checked Footpath 57 at Creedy Bridge and find the recent repair has made the situation much more dangerous than before! Attached is a photo of child walking under the safety rail and onto the muddy slide into the river.

As above.

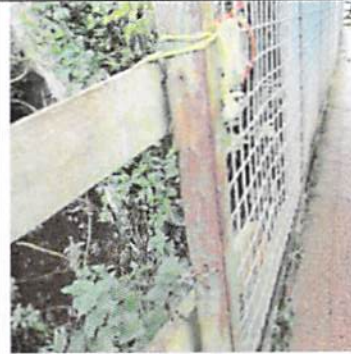
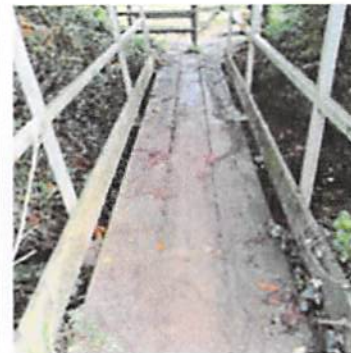
Creedy Bridge- 9th October 2015

Top rail still hanging on baler twine.

The bottom rail has been moved up to the centre, leaving nothing at the bottom so a child can walk under.

Only one new nail holding centre rail because the bent rusty one had not been removed, leaving gap between rail and post, so a second new nail does not go through rail at all.

Child walked under centre rail as I approached. Her mother soon followed and gave permission for the child to do it again for my photo.

Picture showing short distance from rail to water.

A curious new bracket doing nothing - possibly a vague attempt to secure top rail to the wire mesh - to add to the strength of the baler twine!!

The wooden planks are now wet and very slippery

As above.
