Minutes of Credition Town Council's Parish Paths Committee Meeting, held on Tuesday, 13th October 2015, at 5.30 pm, at the Council Chamber, Market Street, Credition

Path	Location	Update	Picture	Resolved actions from Parish Paths Committee Meeting, held on Tuesday, 13 th October 2015 – Minute no. 10
2		Throughout the winter it will be ankle deep in mud.	Taken 18/9/15

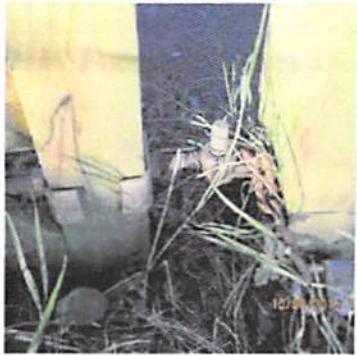
<p data-bbox="1086 486 1433 517">North of Lower Parks Farm</p>	<p data-bbox="1455 114 2057 145">Urban & Rural Tree Services Ltd provided quote.</p> <p data-bbox="1455 189 2063 294">This area may have been picked up by the second cut in September, if not the cutting area will be extended to cover this section.</p>
19	19/28 junction	Gate is difficult to manoeuvre because the lower bracket is not holding the frame of the gate securely, thereby allowing the gate to drop.

<p data-bbox="1455 564 1858 595">Path Warden to organise repair.</p>
19	Going north, part of stretch between Lower Park Farm and Town	<p data-bbox="429 980 1057 1246">Photograph is typical - problem for walkers is that the path is 7/8 feet wide, with three tracks on which to walk. It is divided because of two permanent lines of weeds. The centre track is barely wide enough to walk on, the two outer ones mean brushing head and shoulders with the hedges, and in both cases, walkers get wet legs up to the knees because of the height of the weeds.</p> <p data-bbox="429 1285 1057 1411">This does not deter hardened walkers. But if you have received a complaint, or it is just cosmetic, it appears the only thing to do is to top the lines of weeds as low as possible.</p>	<p data-bbox="1101 980 1420 1042">Footpath 19 northbound above Lower Park Farm</p>

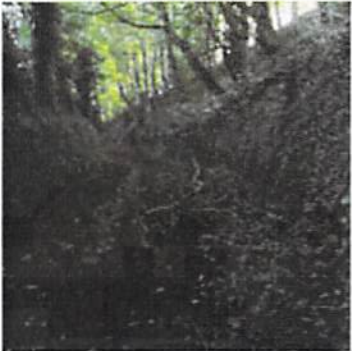
Gate is self-close so no issue. Landowner's responsibility.
22	Downshead Lane	Downshead Lane 01/10/15 - 100 yards east of junction with footpath 23.

No action required.

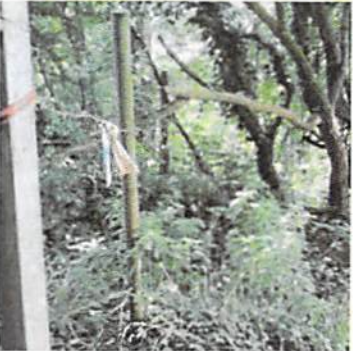
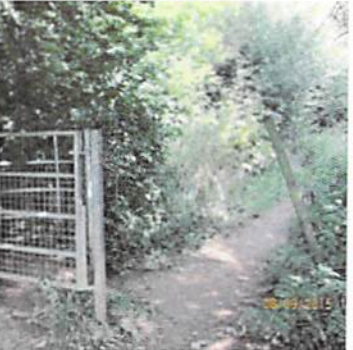
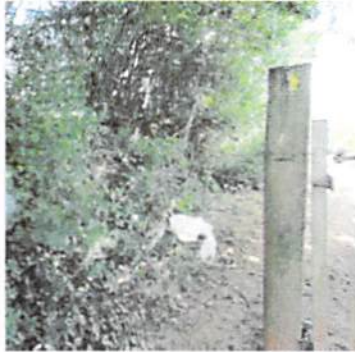
Urban & Rural Tree Services Ltd provided quote. DCC currently cut back as much as necessary. No further action is required.
28		Two metal gates (about 50 yards apart) in very good order but evidence of not being used very much because it is simpler to duck under the single strand of barbed wire than to open the gate and walk around it. Needs replacement of few rows of barbed wire each side of each gate, condition of posts unknown.	<p>Track under single wire</p>

<p>(PTO for additional picture)</p>	Landowners responsibility.

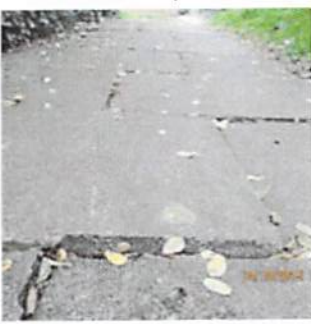
<p>Urban & Rural Tree Services Ltd provided quote.</p> <p>Urban footpath - Office to contact Stephen Tucker.</p>
33	<p>Update as of 1/10/15</p>	<p>Weed killer has been applied recently at the southern end, exit to Barnfield.</p> <p>I have discovered that the current method used to lessen the hazard of tripping where there are overhanging projections is to create a slope made of mud containing grass and weeds which have been treated with week killer. So therefore, one just has to hope that the weed-free mud will stay perfectly in place long enough for fresh grass and weeds to grow in it to keep it in place.</p> <p>There are two areas with yellow marks, presumably for attention, which are:- the surround of a manhole cover, and an overhanging projection trip hazard.</p> <p>There are probably ten similar trip hazards, plus half-dozen that have been addressed by using the "mud method". Perhaps this is a case for a good overhaul?</p>	<p>Mud repair method</p>

<p>Yellow marks – PTO for additional picture</p>

<p>Urban footpath - Office to contact Stephen Tucker.</p>

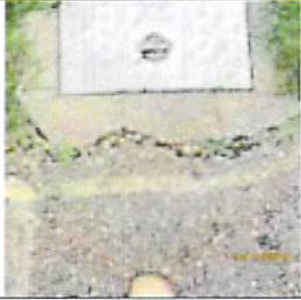
Urban footpath - Office to contact Stephen Tucker.
33		A clearer view of the Mud Method used to repair the path.
